VEHICLE CRASH TESTS OF THE TYPE 70  
BRIDGE RAIL

FINAL REPORT # FHWA/CA/ESC-98-06

STATE OF CALIFORNIA  
**DEPARTMENT OF TRANSPORTATION**  
DIVISION OF NEW TECHNOLOGY,  
MATERIALS AND RESEARCH

<b>16. ABSTRACT</b>  <p>A bridge rail Type 70 was built and tested in accordance with NCHRP Report 350. The Type 70 bridge rail is an 810 mm tall concrete barrier with a sloping face of 9.1 degrees from the vertical. The barrier tested was 22.9 m long and was constructed at the Caltrans Dynamic Test Facility in West Sacramento, California.</p> <p>A total of four crash tests were conducted under Report 350 test Level 4, one with an 820 kg car, two with 2000 kg pickup trucks and one with an 8000 kg van truck. Both the 820 kg and the 8000 kg tests were within the limits of the Report 350 guidelines. The first test of the 2000 kg pickup was unsuccessful due to a snagging problem with a floating hub on its extended rear axle. The problem with the first pickup led to a retest with a different pickup that did not have the extended floating rear hub. The second test was successful, with all results within the guidelines.</p> <p>The Type 70 is recommended for approval on California highways requirin

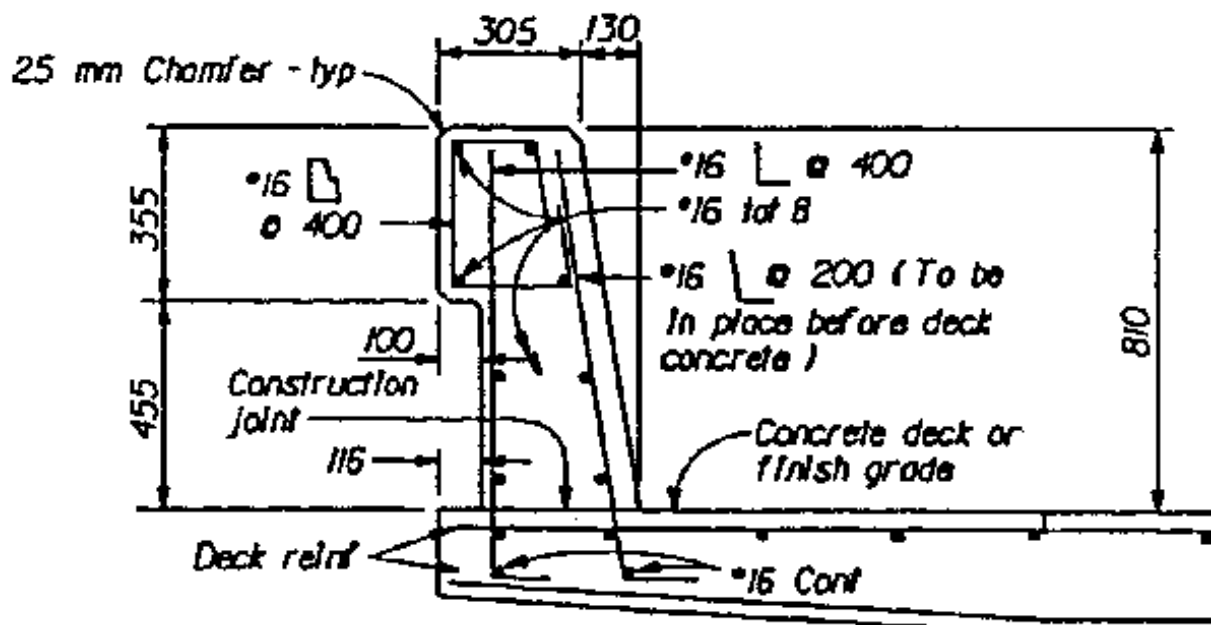
Figure 2.1 - Type 70 Bridge Rail

The design configuration for the Type 70 consists of a single-slope profile at 9.1 degrees and 810 mm high (See Figure 2.1). The reinforcing steel is covered with a minimum of 25 mm of concrete and all longitudinal reinforcing is terminated in 90 degree hooks. The 810 mm high design was used in our tests as the shortest configuration to be placed in service. This also provided a more conservative test configuration. Additional drawings for the type 70 barrier can be found in Appendix 7.5.

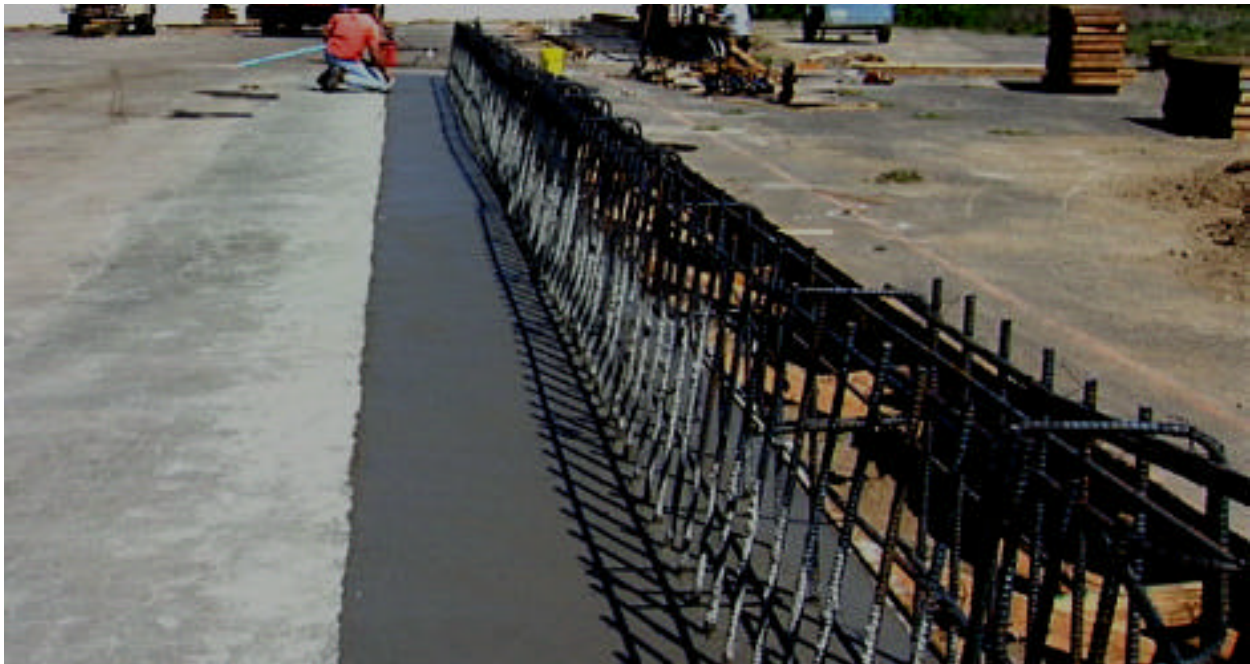
**Figure 2.2 - Reinforcing Steel (From The Front)**

The rail was constructed in three main stages. The concrete for the anchor block was poured with the reinforcing steel extending horizontally through the side. This reinforcing steel provided a construction joint between the anchor and the cantilevered deck. When the cantilevered deck was fabricated, vertical reinforcing steel extended upward. The additional steel was tied into place and the concrete was poured creating a cold joint at the deck surface. Wood forms were used in all pours and the concrete was vibrated in lifts.

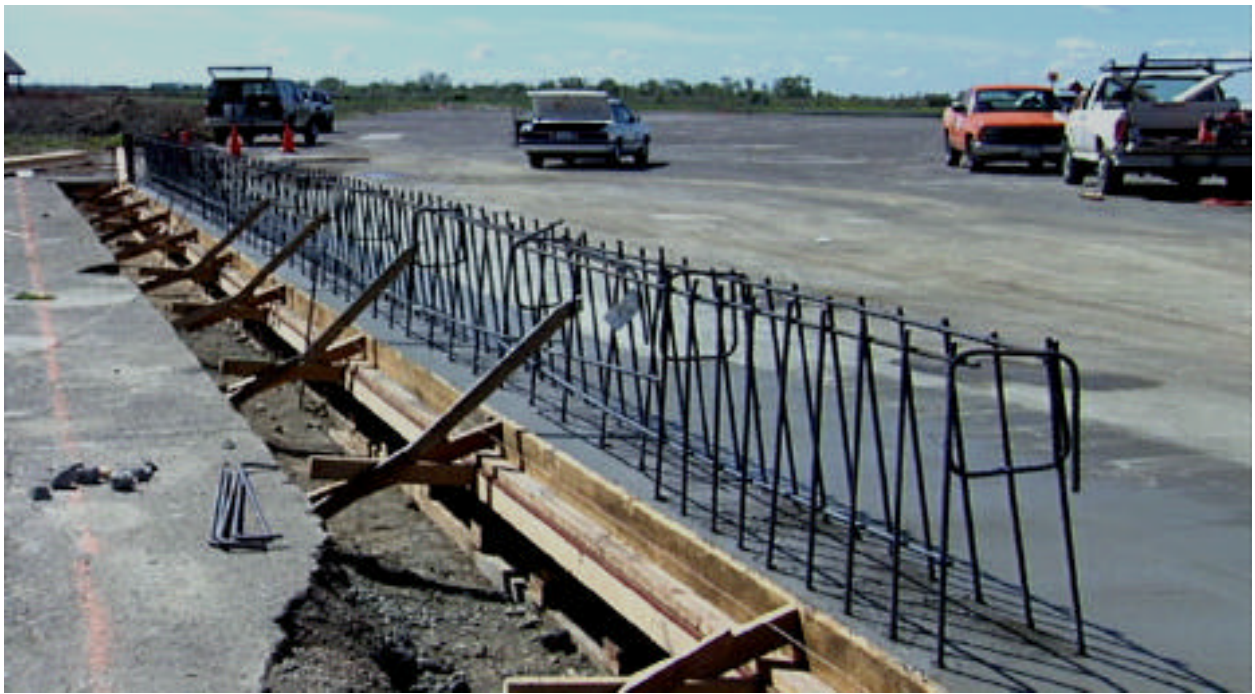
**Figure 2.3 - Reinforcing Steel (From Behind Barrier)**

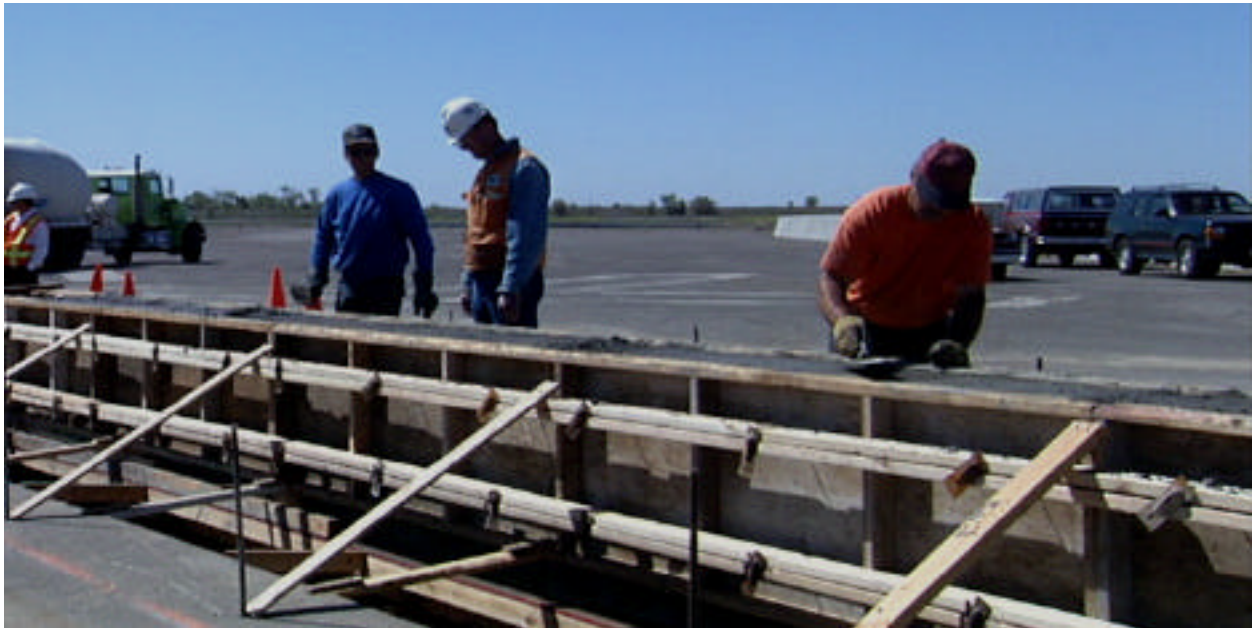
**Figure 2.4 - Wood Forming And Finish Work**

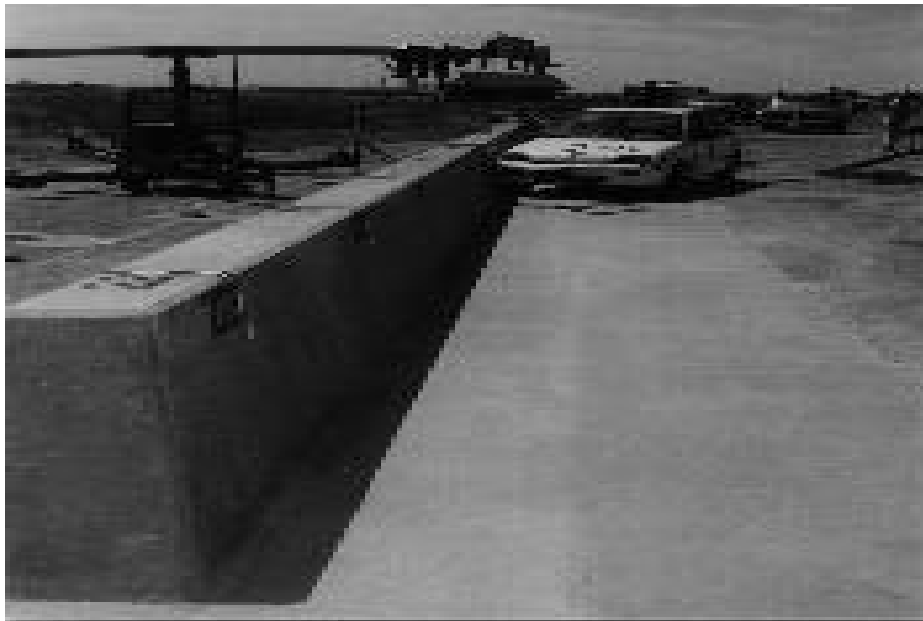
**Figure 2.5 - Downstream View Of The Type 70 Barrier With Vehicle 511**

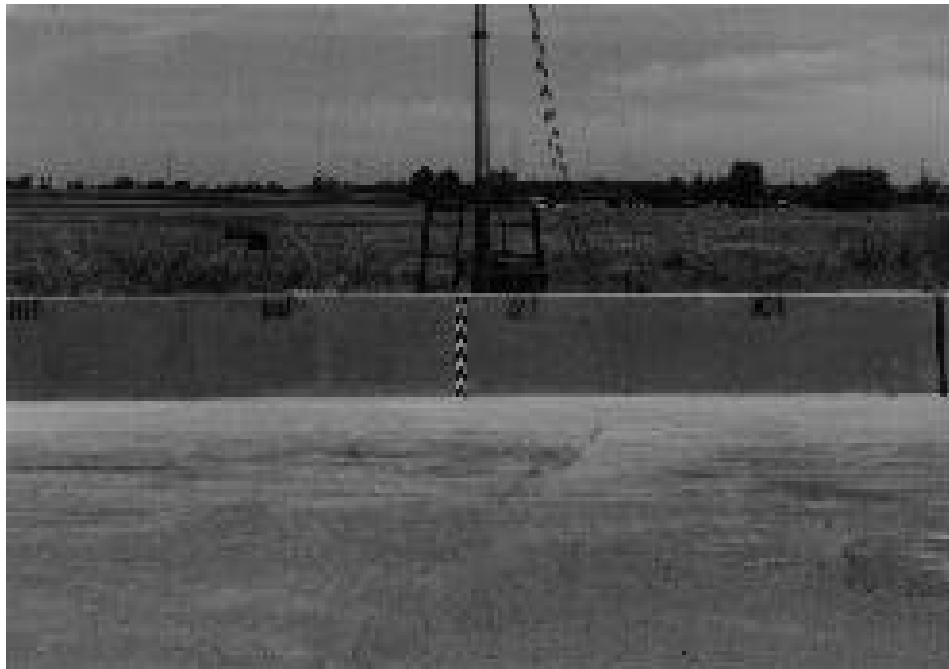
**Figure 2.6 - Side View Of The Type 70 Barrier At The Impact Location**

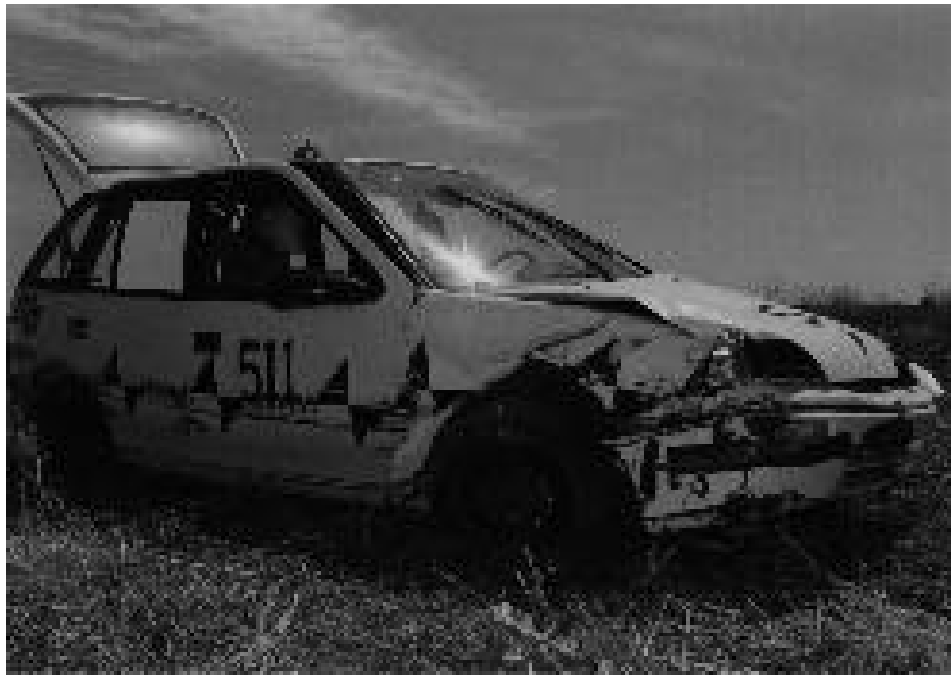
**Figure 2.9 - Right Front Of Vehicle 511 After Impact**

The right front section of the vehicle sustained crushing of the bumper and frame, damage to the suspension and a flat tire. The hood crumpled, but did not penetrate the cab.

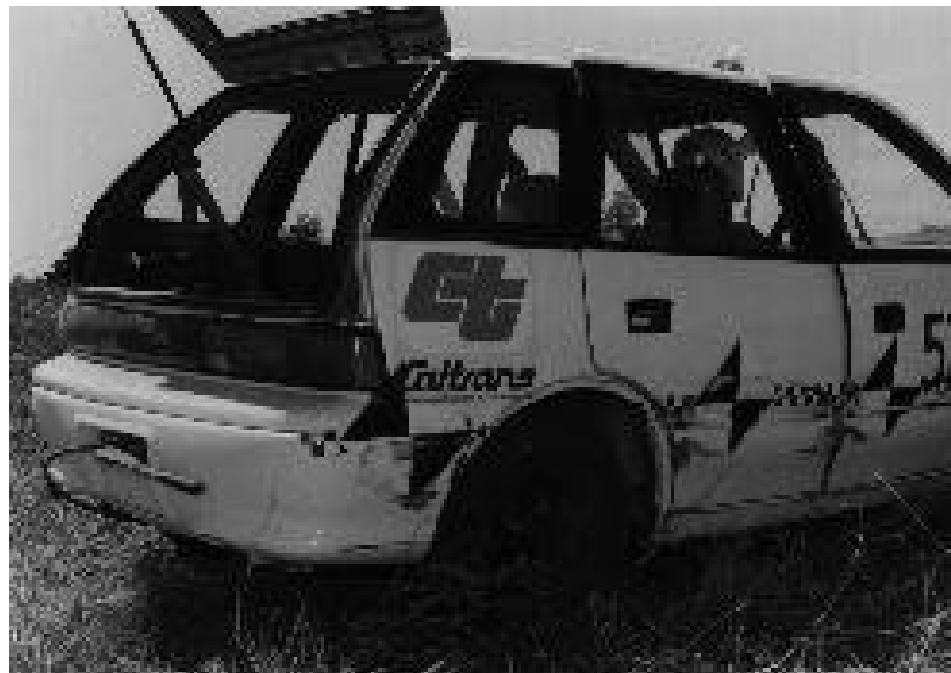
**Figure 2.10 - Right Rear Of Vehicle 511 After Impact**

As the vehicle turned parallel to the barrier, the sheet metal on the entire right side came into contact with the barrier face. The rear right tire rubbed along the barrier, but was not damaged beyond moderate scuffing.

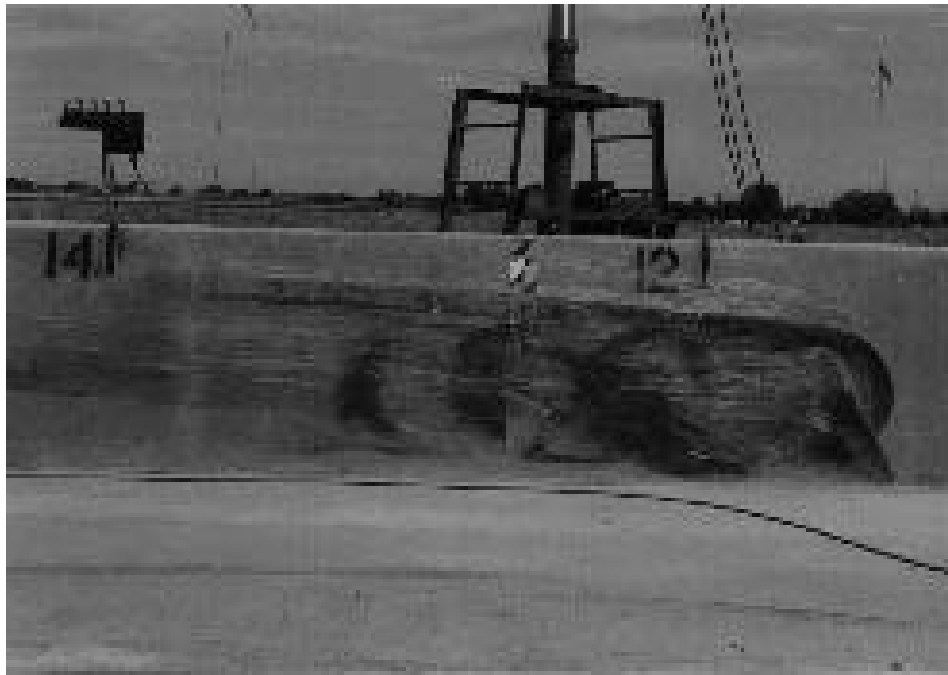
**Figure 2.11 - Test 511 Impact Scuff Marks On The Type 70 Barrier**

Barrier damage was cosmetic only, consisting of scrapes and tire marks. Both of the right side tires left marks along the face of the barrier for the 6.5 meters of contact. Small amounts of concrete spalled from the face of the barrier where the vehicle's sheet metal made contact.

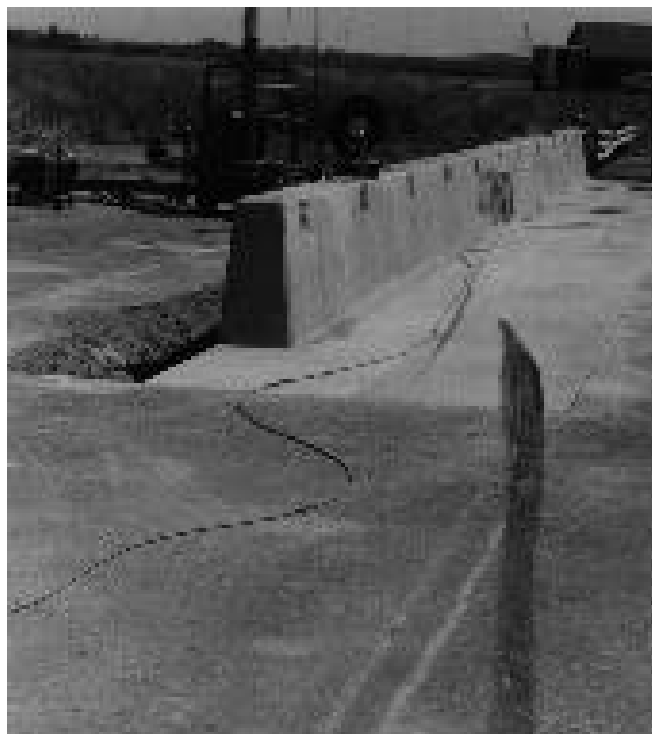
**Figure 2.12 - Test 511 Downstream View Of The Type 70 Barrier**

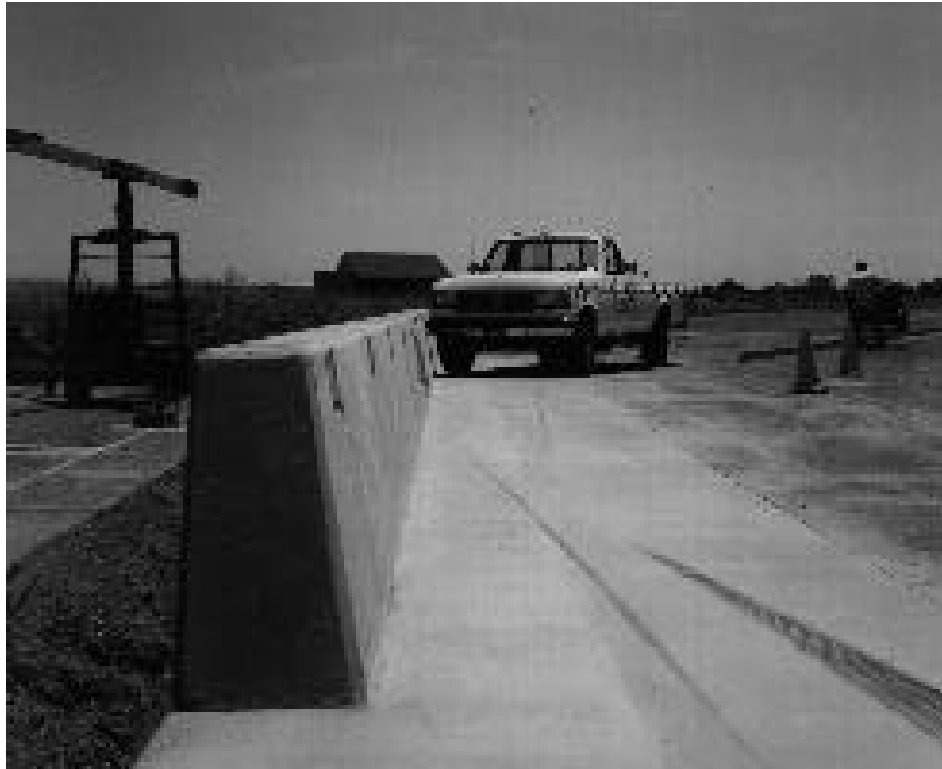
**Figure 2.16 - Barrier Profile and Vehicle for Test 512**

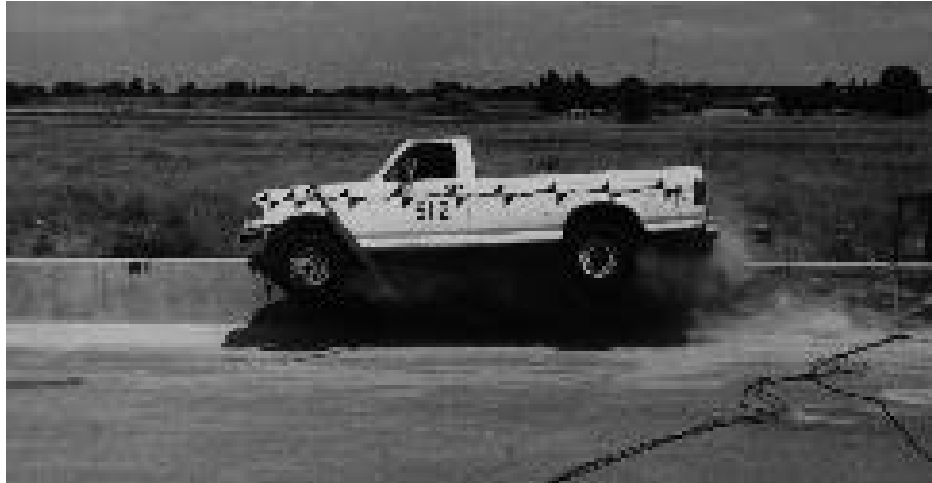
**Figure 2.18 - Side View Of Vehicle 512 During Impact**

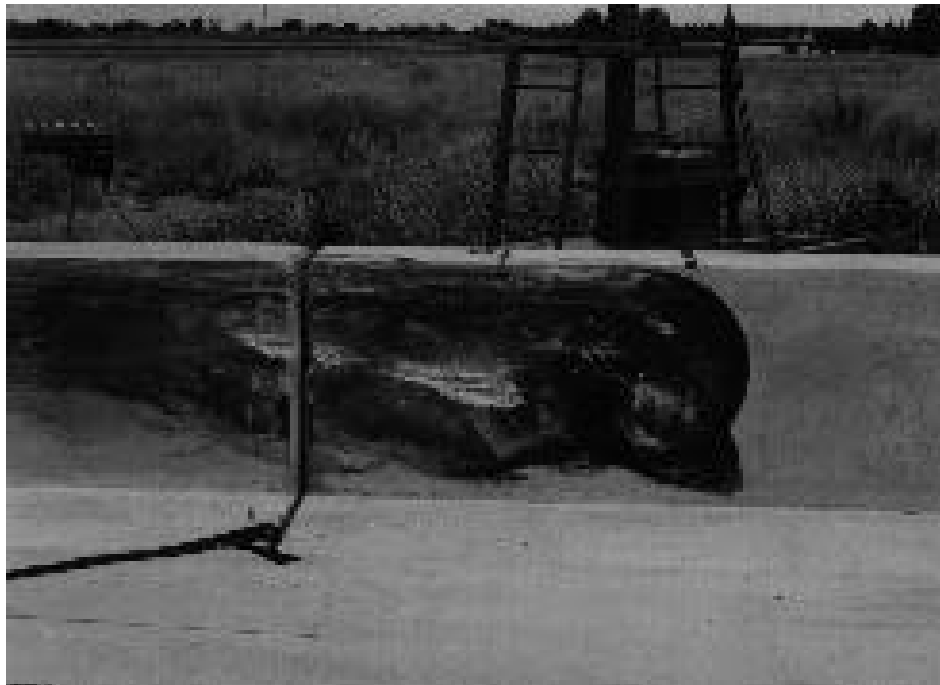
**Figure 2.19 - Scuff Marks on Barrier for Test 512**

The barrier sustained a 200 mm-long gouge just upstream from the impact area. The gouge was 20 to 100 mm wide and up to 20 mm deep. A second gouge, located just downstream from impact, was only half the size of the first. Other barrier damage was cosmetic only, consisting of scrapes and tire marks. Both of the right side tires left marks along the face of the barrier for the 6.5 m of contact. Small amounts of concrete spalled from the face of the barrier where the vehicle's sheet metal made contact.

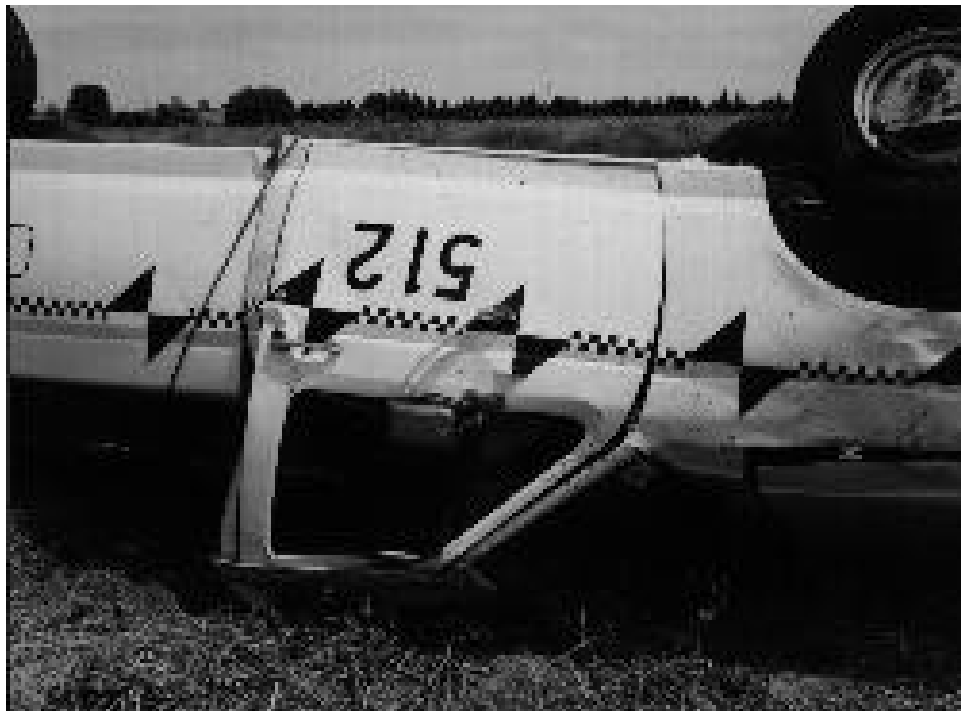
**Figure 2.20 - Final Position Of Test Vehicle 512**

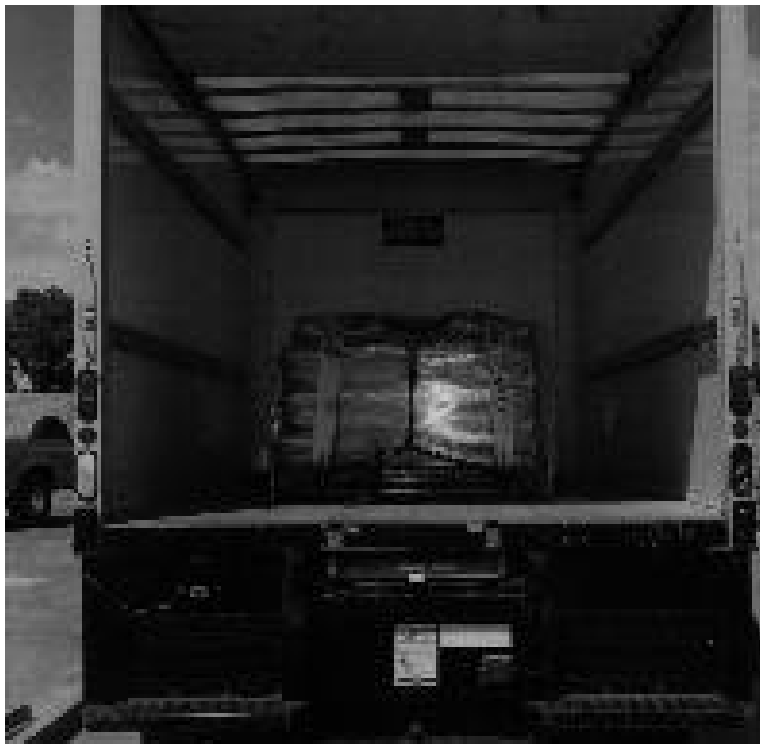
**Figure 2.25 - Overall View Of Ballast In Test 513**

The 2908 kg of ballast, comprised of two separate pallets of sand bags strapped down to the cargo floor, shifted slightly during impact. While the pallets were constrained by 150 mm angle iron, the sand bags were only held down by 100 mm trucking straps. Consequently, the sand was allowed to shift to the right by about 100 mm. It is unlikely that the shifting sand affected the test significantly. None of the sand bags broke lose during the test.

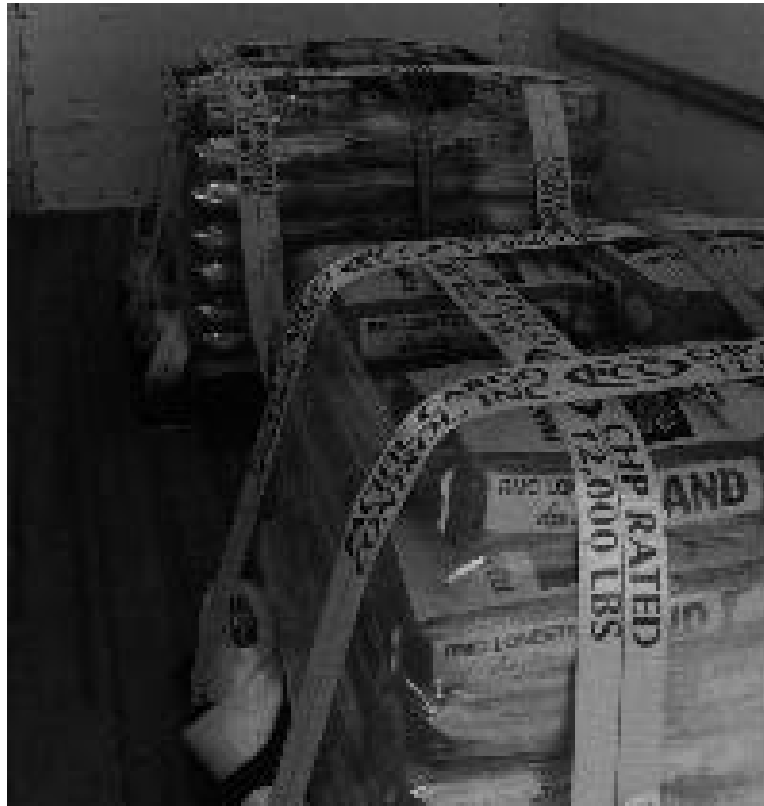
**Figure 2.26 - Two Pallets Of Sand Used For Ballast on Test 513**

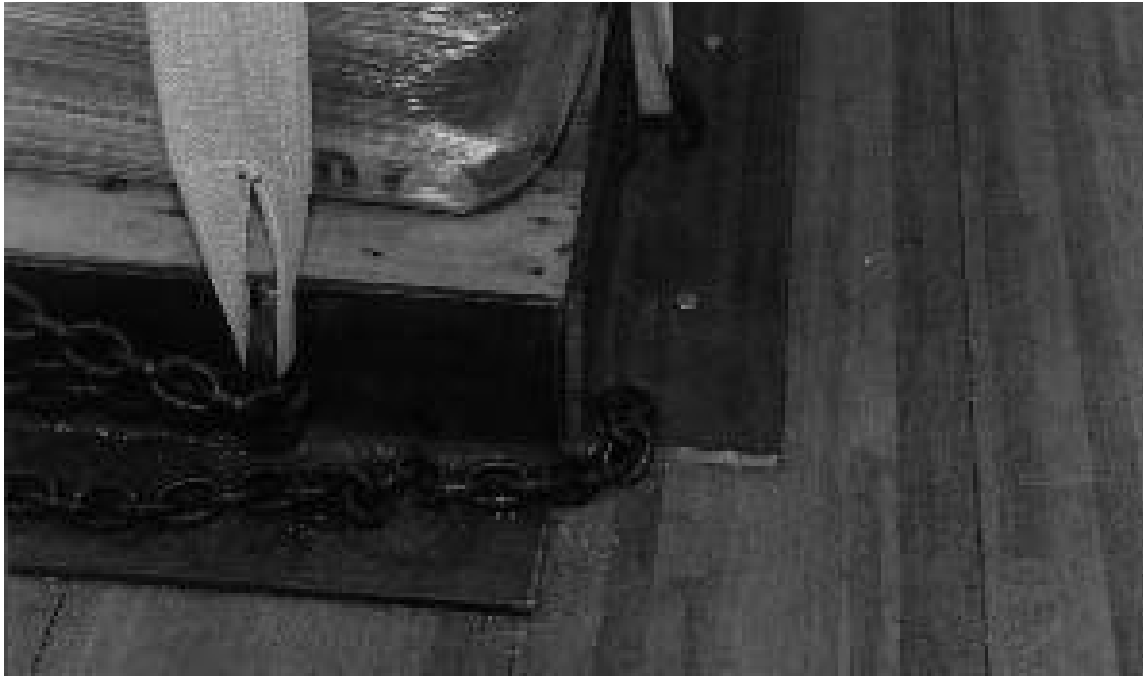
**Figure 2.27 - 150 mm Angle Irons Were Used To Constrain The Pallets Of Sand for Test 513**

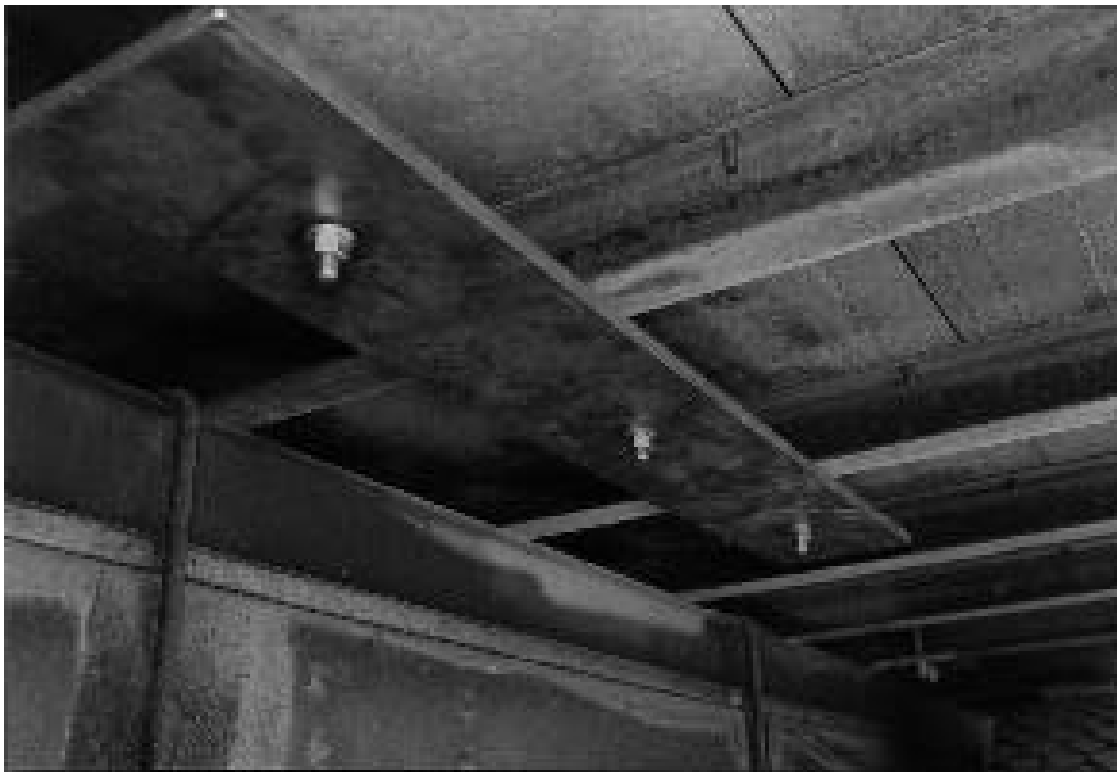
**Figure 2.28 - Keeper Plates Used With The 150 mm Angle Iron on Test 513**

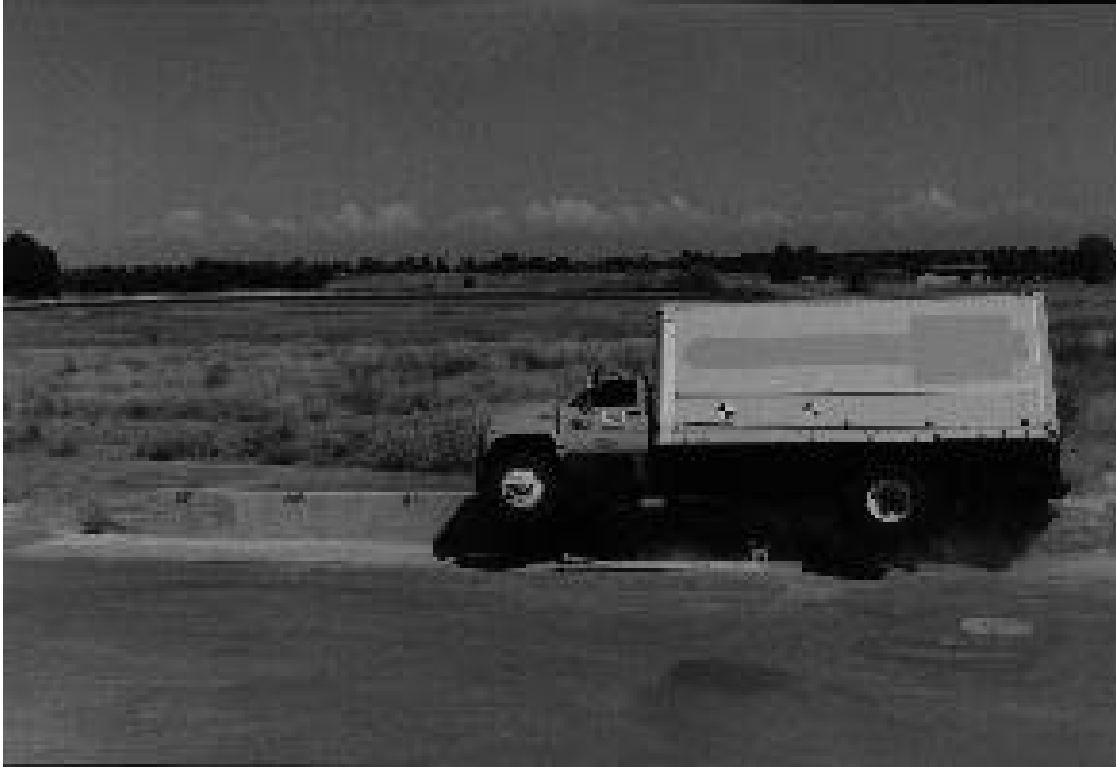
**Figure 2.29 - Vehicle 513 During Impact**

impact the vehicle rolled to the right lifting both left wheels off the ground about 1 m. The U-bolt holding the front right leaf springs to the front axle broke, allowing the right front wheel to be pushed back under the cab. The vehicle continued to make contact with the barrier for approximately 15 m, after which the vehicle righted itself and continued to a point of rest on an earth berm.

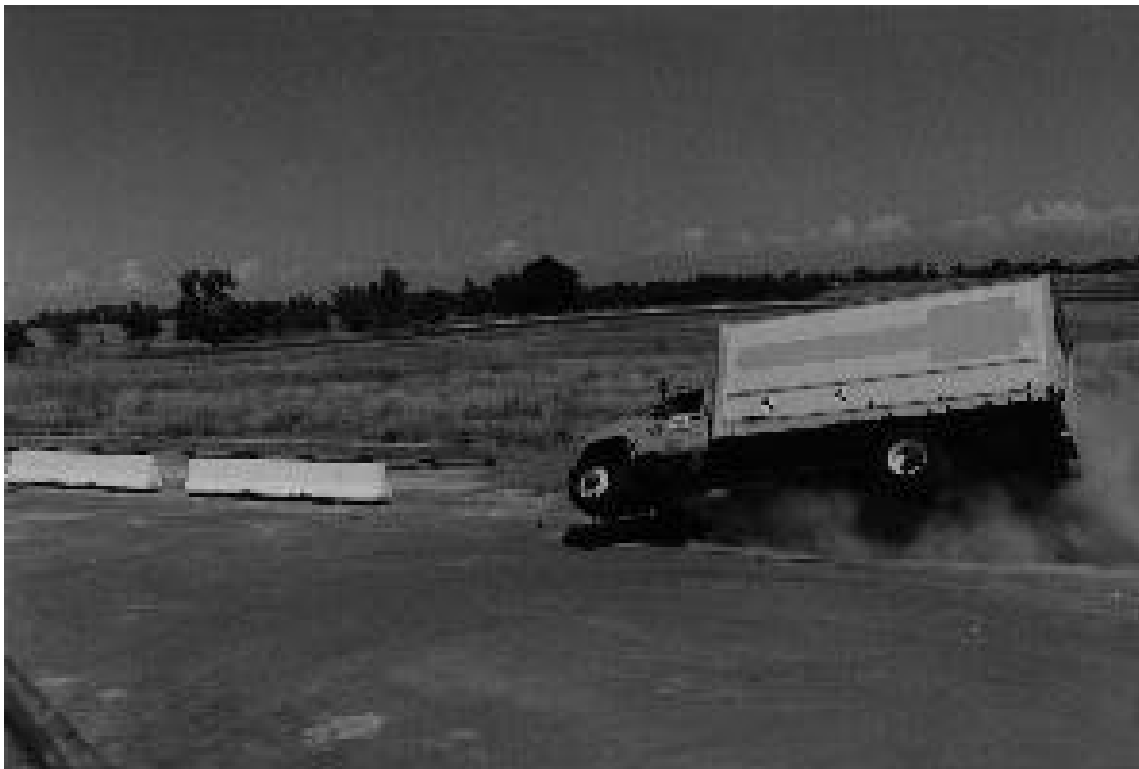
**Figure 2.30 - Vehicle 513 During Impact**

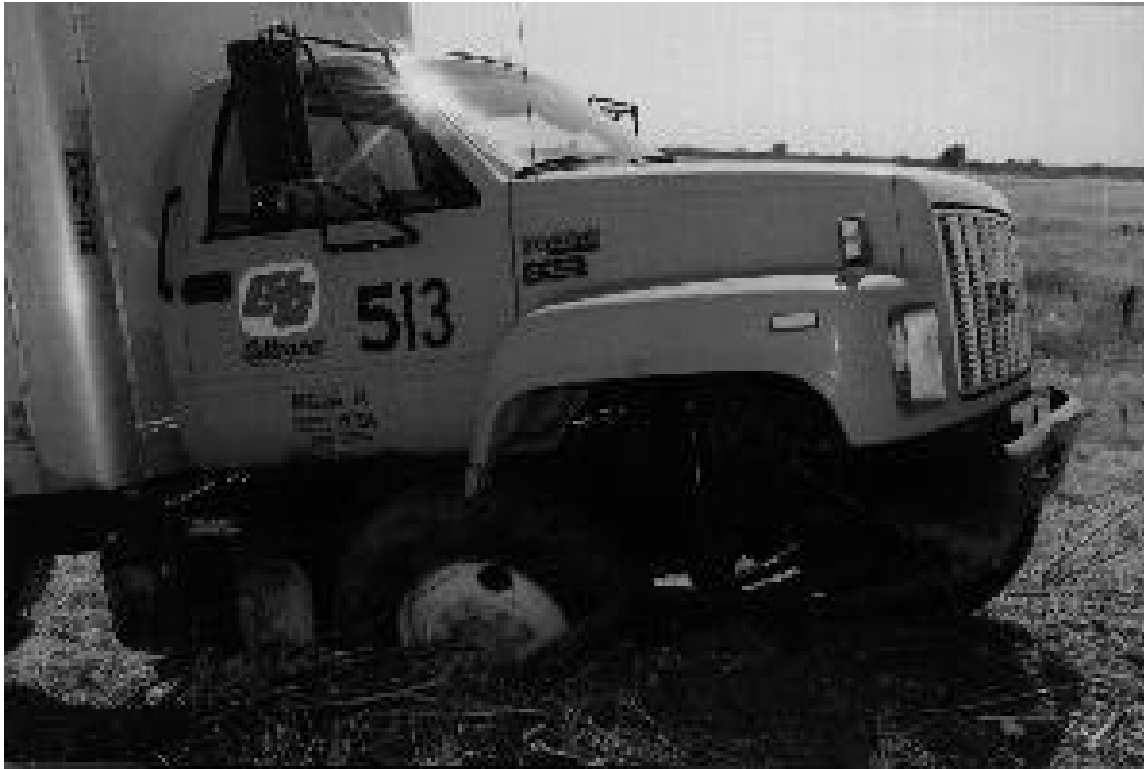
**Figure 2.32 - Right Side Of Cab For Test 513 After Test**

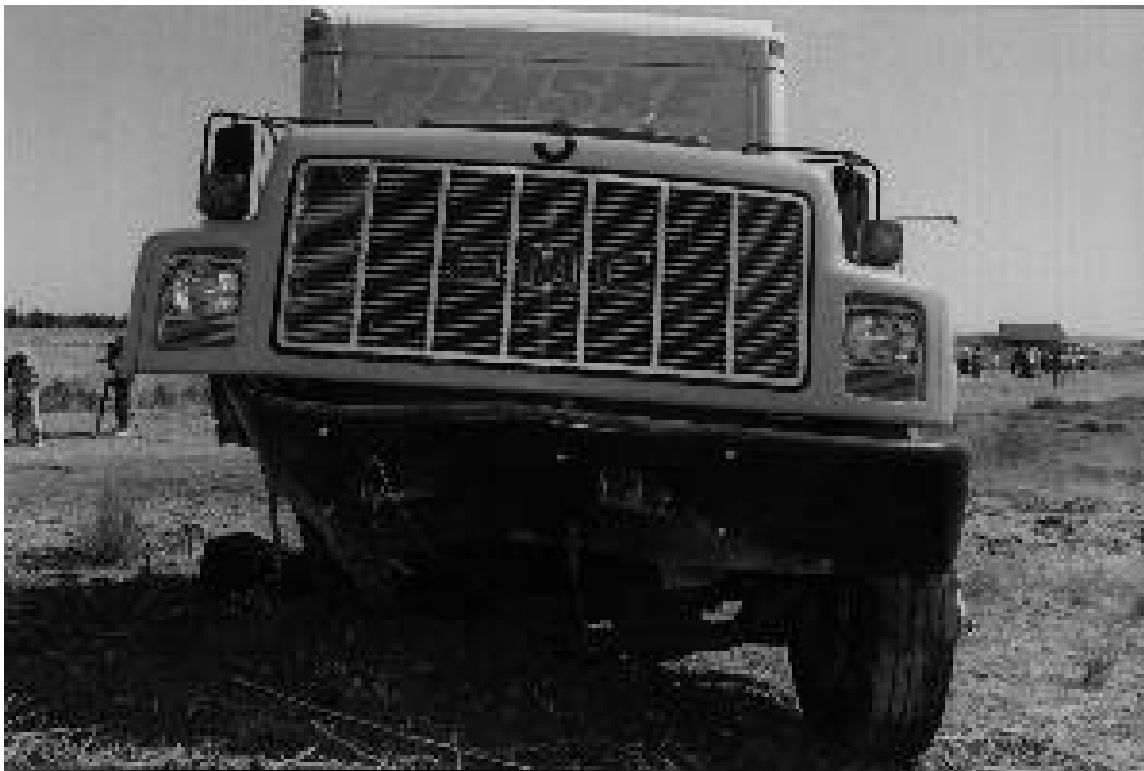
**Figure 2.33 - Front Of Vehicle 513 After Test**

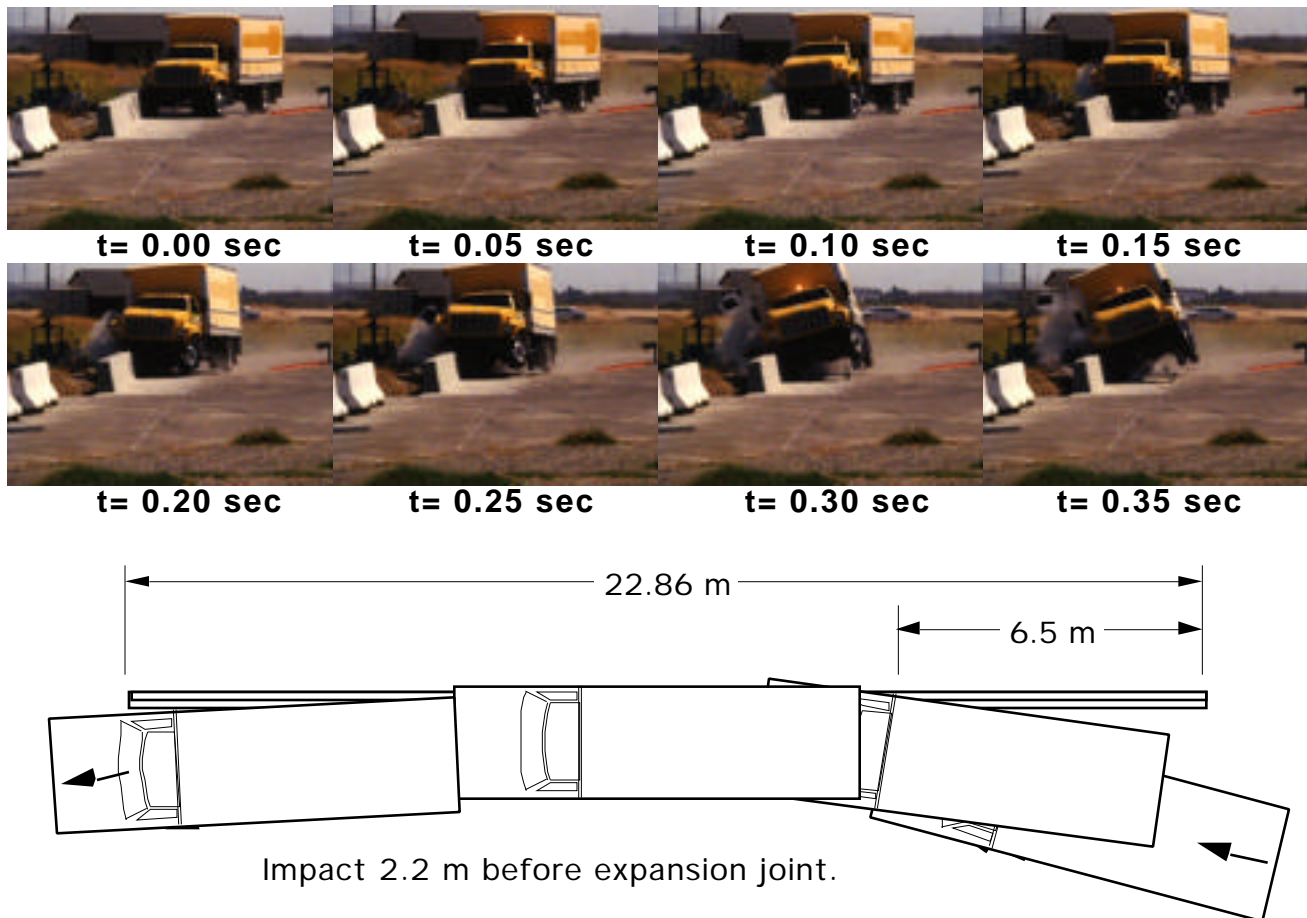
Figure 2.34 - Test 513 Data Summary Sheet

Type: Type 70 Bridge Rail  
Length: 22.9 m

The barrier was scraped during the time of vehicle contact. Damage was mainly limited to minor spalling.

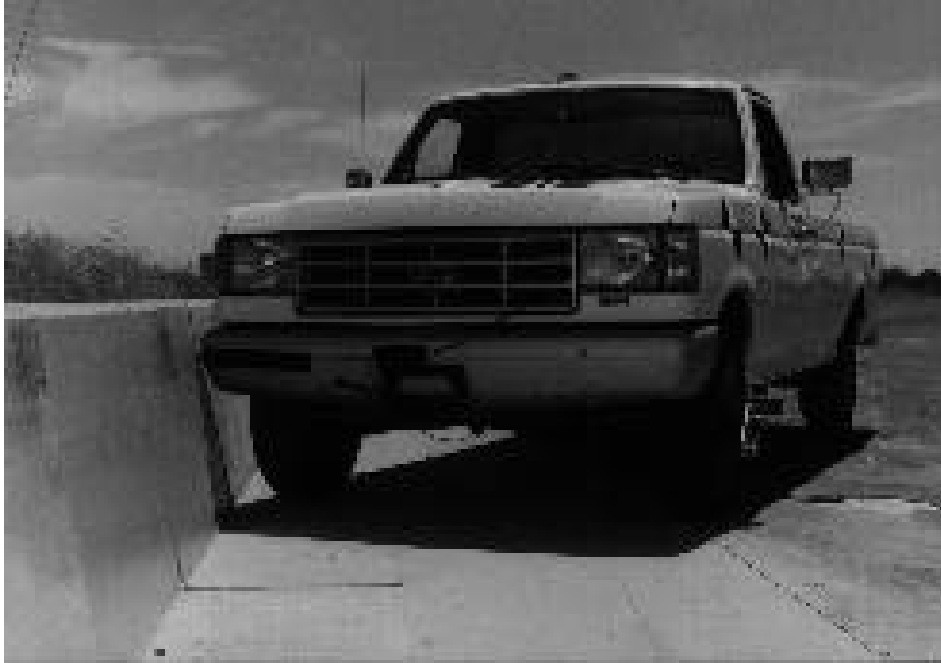
**Figure 2.37 - Vehicle 515 Bumper Location (Front Angle)**

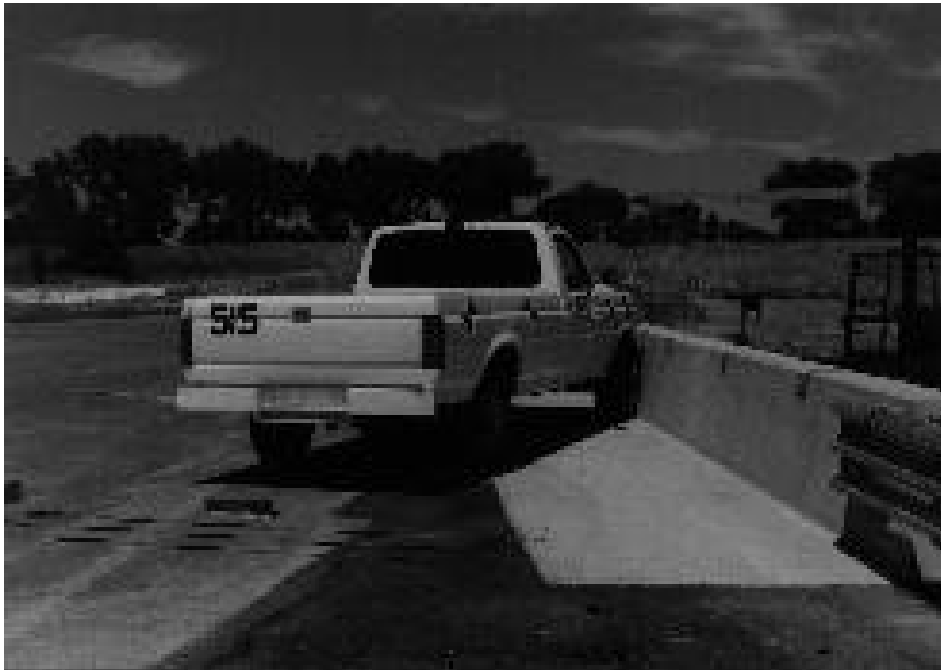
**Figure 2.38 - Vehicle 515 Bumper Location (Back Angle)**

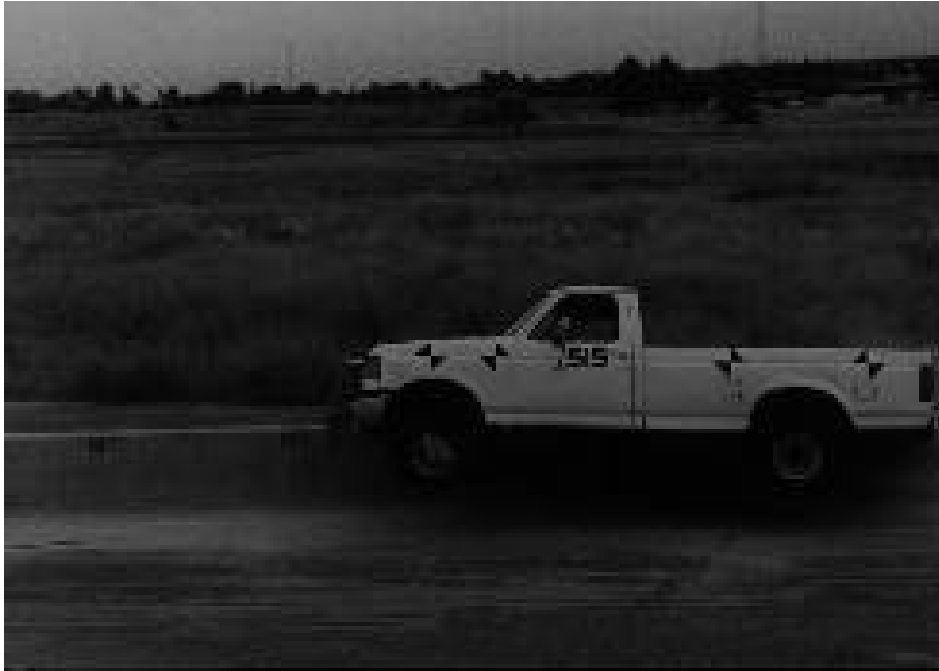
**Figure 2.39 - Vehicle 515 During Impact**

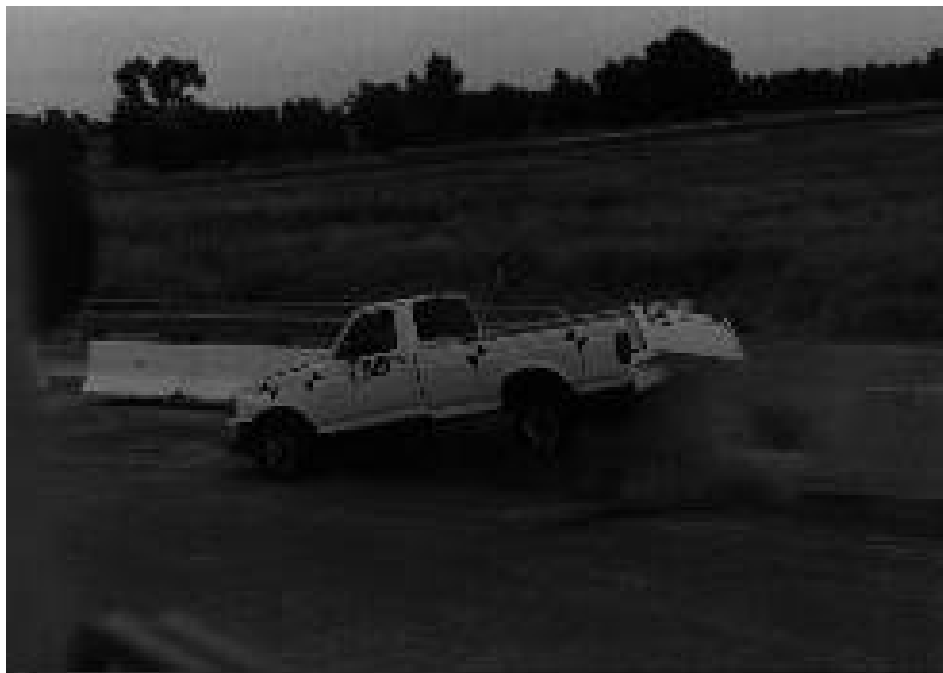
**Figure 2.40 - Vehicle 515 During Impact**

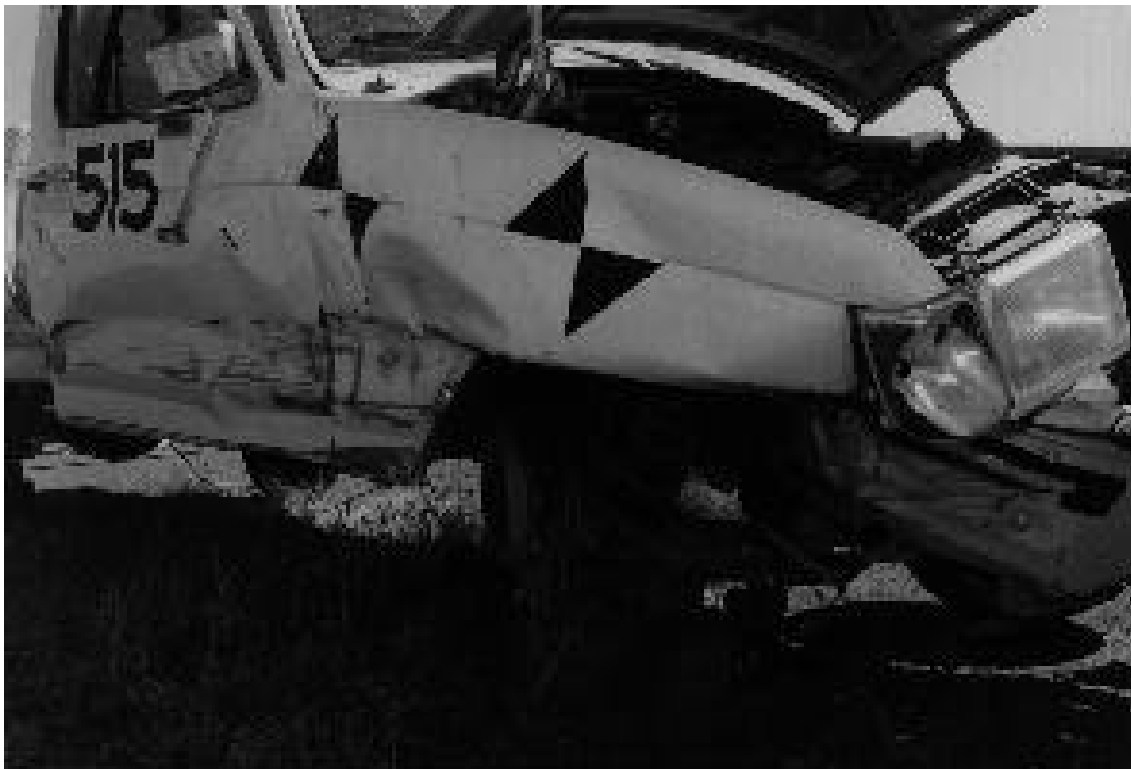
**Figure 2.42 - Front Right Side Of Vehicle 515 After Impact**

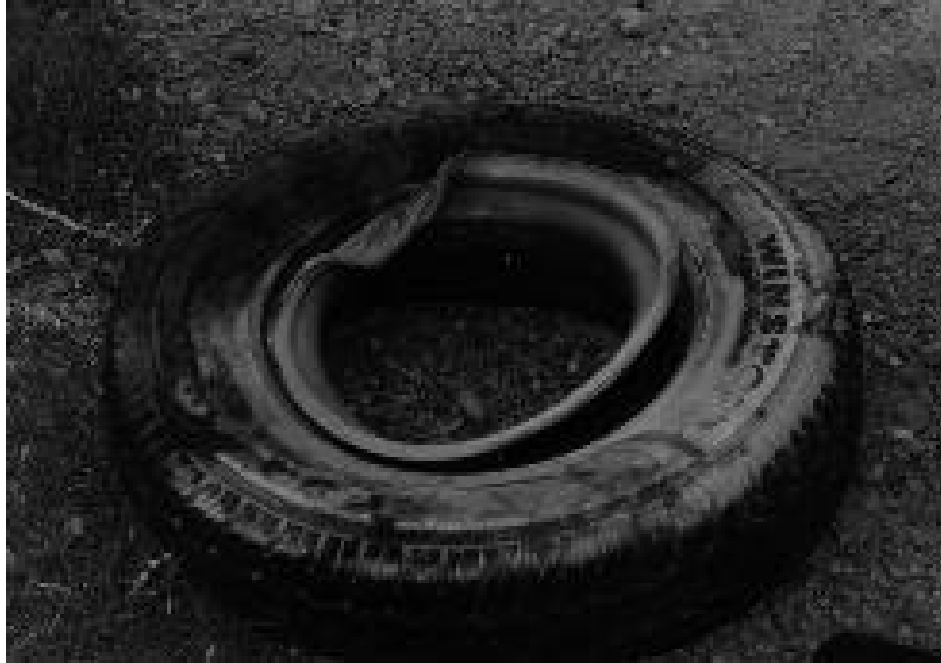
**Figure 2.43 - The Front Right Tire Of Vehicle 515 After Impact**

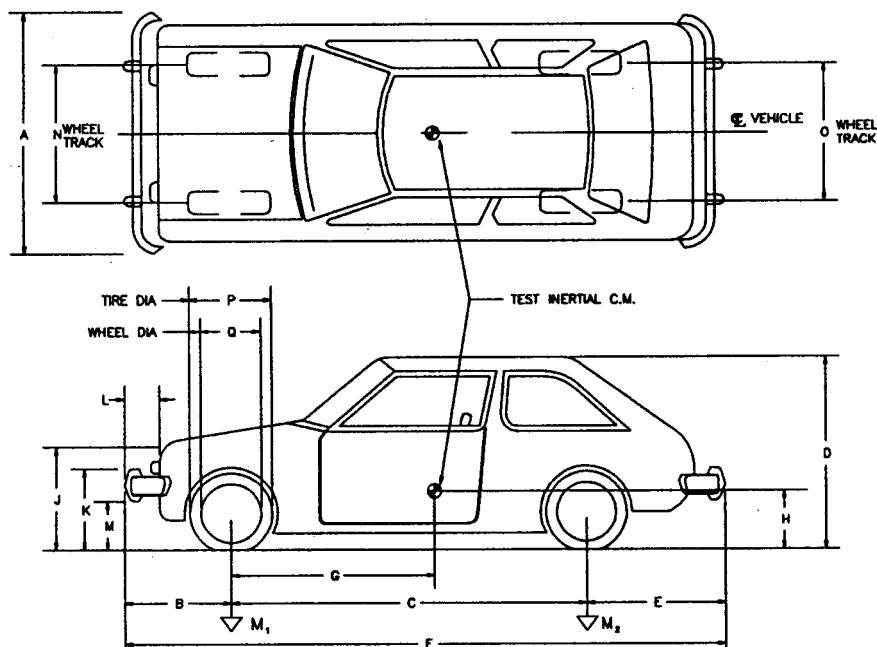
DATE: 5/6/95 **Table 7.1 - Test 511 Vehicle Dimensions** TEST NO: T511  
 VIN NO: 2CIMR6467N6743016  
 MAKE: GEO  
 MODEL: METRO YEAR: 1992 ODOMETER: 57560 (MI) TIRE SIZE: 155R1276S  
 TIRE INFLATION PRESSURE: 44 (PSI)  
 MASS DISTRIBUTION (kg) LF 257 RF 246 LR 169 RR 170  
 DESCRIBE ANY DAMAGE TO VEHICLE PRIOR TO TEST: 250 mm CRACK IN WINDSHIELD

ENGINE TYPE: 3 CYL  
 ENGINE CID: 1.5 LITER  
 TRANSMISSION TYPE :  
☒ X AUTO  
☐ MANUAL  
 OPTIONAL EQUIPMENT:
